## Check-Out

2 Bedroom Furnished

11th January 2022

Arnold Inventories, Inventory and Check-In  
Report dated 1<sup>st</sup> May 2017

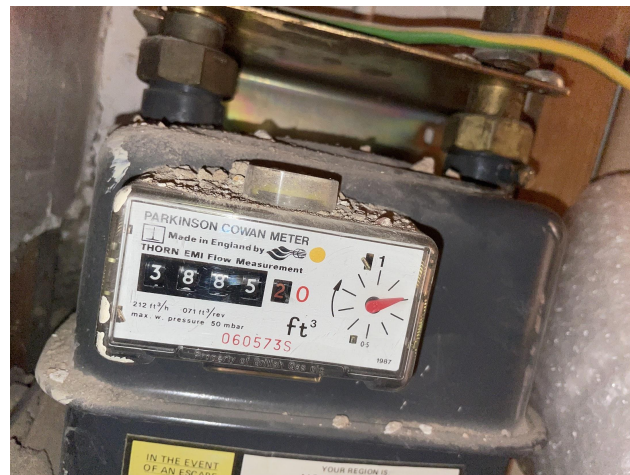
Gas Meter

23.		1 x under stairs cupboard storage unit with 2 x white painted doors Doors have chrome and glass pull handles  To interior: Gas meter	Cupboard is in cupboard condition Unable to fully inspect and unable to take gas meter reading due to cupboard being in the high level	As per check-in
